# Special Protection Area Program Annual Report 2004

PREPARED BY THE MONTGOMERY COUNTY DEPARTMENT OF ENVIRONMENTAL PROTECTION IN COOPERATION WITH THE  
DEPARTMENT OF PERMITTING SERVICES

# SPA Annual Report for the 2004 Monitoring Period

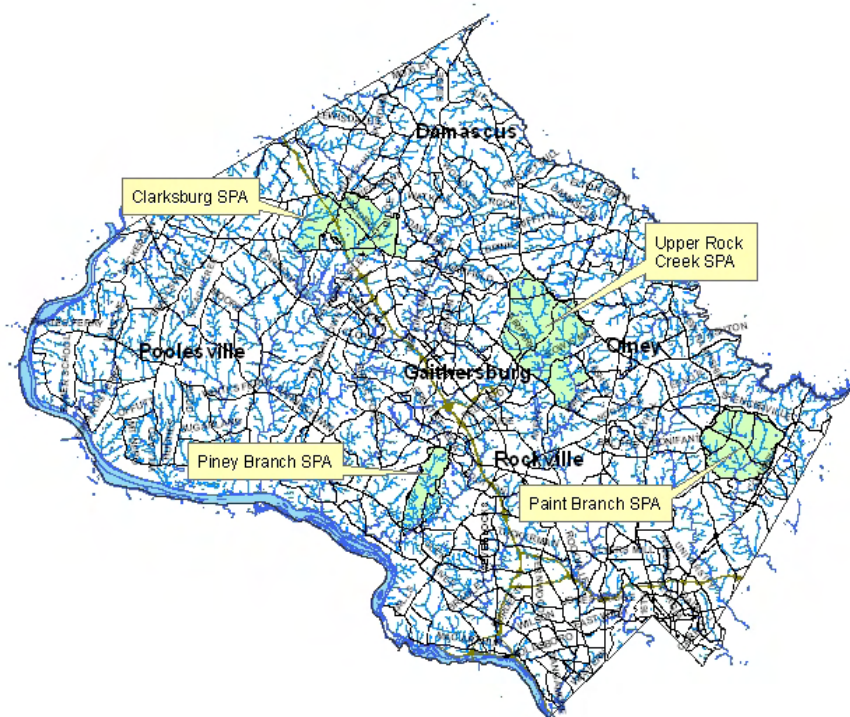
Figure 1. Montgomery County Special Protection Areas.

The County Council has designated four areas within Montgomery County as Special Protection Areas (Figure 1). The designated areas are: the Clarksburg Master Plan SPA,

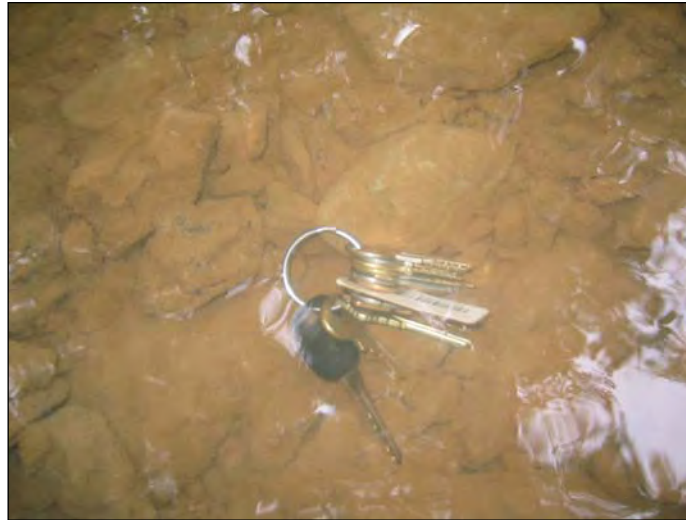
Figure 5. Fine Sediments in Town Center Tributary

Streams in sub-watersheds where massive grading and filling is occurring as part of the development process are showing greater decline in biological health. In the Clarksburg SPA, for example, the Town Center tributary receives runoff from moderate to high intensity development within the new Clarksburg Town Center. Stream conditions declined sharply in this tributary from levels indicative of 'good' condition (sustained during a six year period, 1997 – 2002) to 'poor' condition in 2003 and 2004. Several observed stream impacts were initially responsible for decline in this area, including: severe drought, high rates of algae growth, a water main break and associated sedimentation. Stream flows in the region were near or above average during 2003 and 2004 providing favorable conditions for biological communities to recover from severely stressful drought conditions that existed during 2002. However, the continued presence of fine sediment coating the stream bottom, primarily the result of discharge from construction sites, appears to be hindering the recovery of biological health. Even with sediment control structures and structures functioning at high levels (80% removal of suspended sediment, on average) some of the uncaptured fine sediment discharges still reach and impact stream channel habitat and resident aquatic life (Figure 5).
